MEMORANDUM

SUBJECT: Engineering Geologic Review of Timber Harvesting Plan 1-20-00084 SON

Inspection Date: July 24, 2020

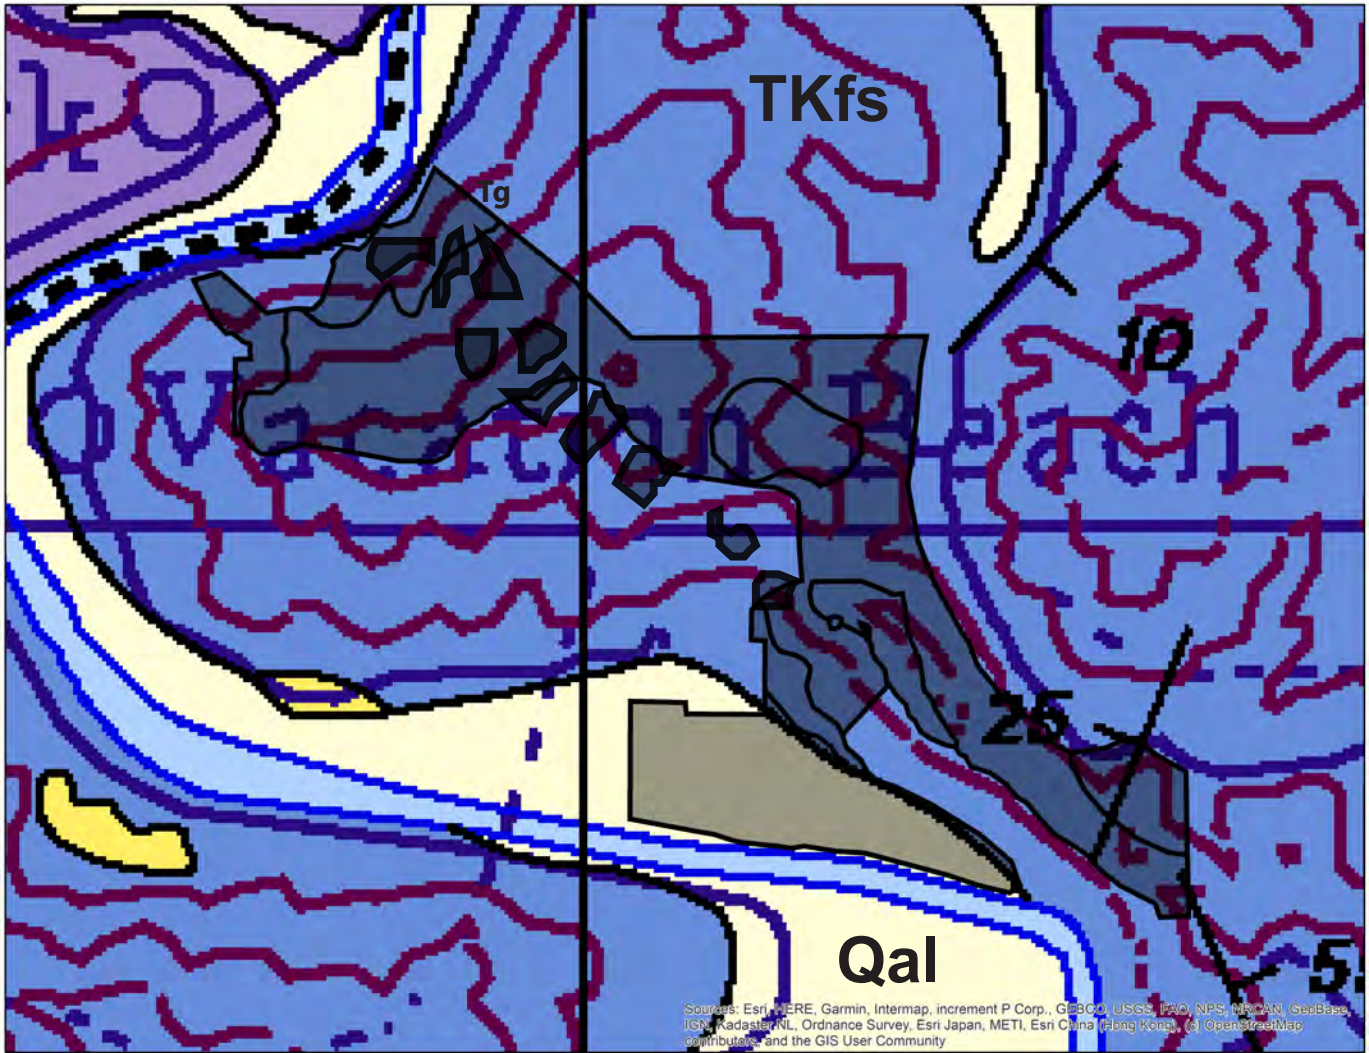
Date: Aug. 2020	Regional Geologic Map To Accompany Engineering Geologic Review of THP 1-20-00084 SON	Figure: 1
Scale: 1" = 1250'		
Approved By: CGS

Regional geologic mapping (Blake and others, 2002. Figure 1) identifies Tertiary to Cretaceous-age Coastal or Central Belt Franciscan Formation as underlying Timber Harvest Plan 1-20-00084 SON, consistent with descriptions provided in the plan-attached geologic report (Best, 2020). The Franciscan Formation is described as massive, brown- and orange weathered, green to gray feldspathic-lithic wacke, including thin beds of sandstone, dark-gray shale and slate (Blake and others, 2002). The Franciscan Formation is overlain by Quaternary-age alluvial fan and fluvial deposits along the Russian River floodplain within the southwestern THP boundary (Blake and others, 2002). The fluvial deposits are described as brown or tan, medium dense to dense, gravelly sand or sandy gravel that generally grade upward to sandy or silty clay (Blake and others, 2002). Bedrock observed during the PHI generally consisted of brownish gray sandstone, consistent with mapping and descriptions made by Blake and others (2002) and Best (2020).

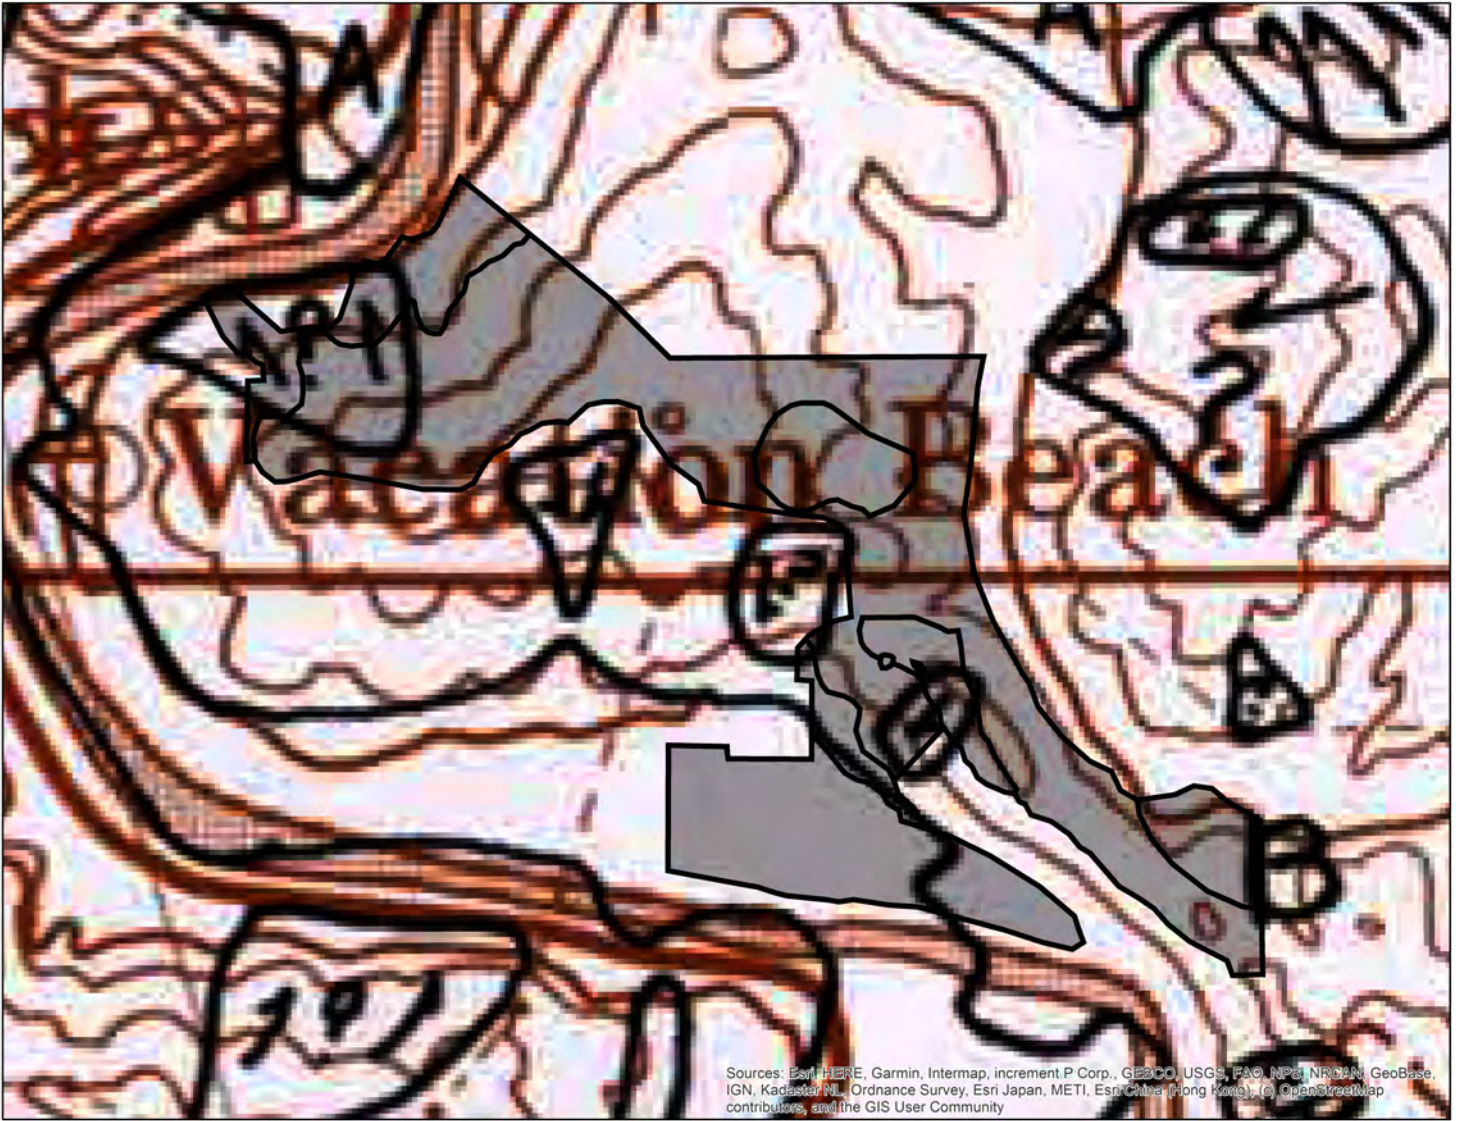
Regional Landslide Map
To Accompany
Engineering Geologic Review of
THP 1-20-00084 SON

Site slopes (ranging from 40 to 70± percent gradients) drain to the southwest, northwest, northeast and east via Class II and Class III watercourses that are tributaries to Mays Canyon and the Russian River, both Class I watercourses. Regional geologic mapping (Huffman and Armstrong, 1980, Figure 2) and plan-attached site-specific mapping (Best, 2020) identify areas of shallow- and deep-seated landsliding as underlying and downslope of the proposed THP boundary. The unstable areas were visited during the PHI and are discussed below under the General Observations portion of this memo.

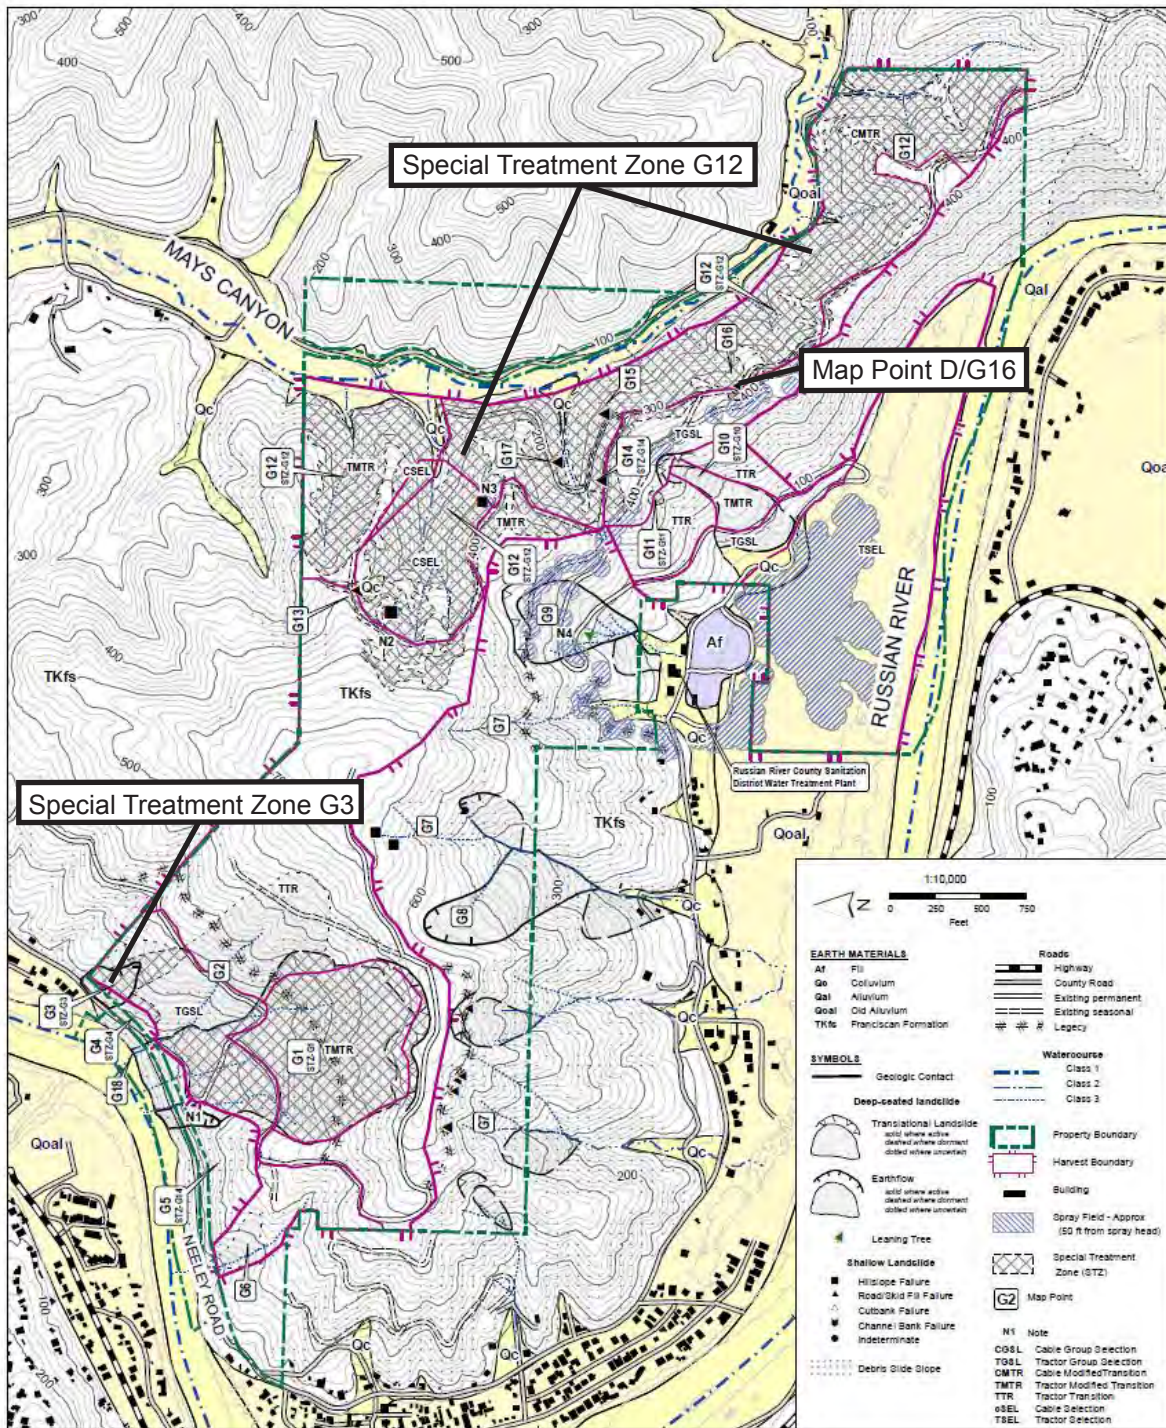
Date: Aug. 2020	Site-Specific Geologic Map To Accompany Engineering Geologic Review of THP 1-20-00084 SON	Figure: 3
Approved By:		
CGS

Map Point 3: The THP proposes to install an 18-inch diameter culvert where an existing seasonal road crosses a Class III watercourse at Map Point 3. The seasonal road switches back along the slope and crosses the watercourse at two additional locations (Map Points 2 and 7). Based on review of flow calculations included in Section V of the THP, it appears that the calculated flow at Map Point 7 is larger than the calculated flow at Map Point 3. Map Point 7 is located upstream of Map Point 3. Typically, a watercourse crossing located downstream of another crossing experience a higher flow due to an increase in drainage area and slope runoff, and accumulation of ground water. This suggests that either the flow at Map Point 7 is overestimated or the flow at Map Point 3 is underestimated. During the PHI, the RPF stated that he suspected that the acreages used in the calculations were incorrect. After the PHI, the RPF provided revised calculations using recalculated acreages which appear more representative of the observed watersheds upslope of the crossings. As a result, the RPF proposes to increase the culvert at Map Point 3 from 18-inch diameter to 24-inch diameter.

Special Treatment Zone G10: The plan-attached geologic report (Best, 2020) identifies an approximately 4-acre deep-seated landslide as underlying the southwestern THP boundary. The unstable feature toes into the Russian River floodplain approximately 800 to 900-feet from the active channel and is characterized a rounded scarp above a 40 to 70-percent benched failure slope that supports generally straight-standing second growth conifers. The slide is located within an area proposed for transition and group selection harvesting. The uppermost approximately 0.1 to 0.2-acre of the head scarp of the slide, where group selection harvesting is proposed along 60 to 70-percent slopes, is located within a Russian River Sanitation District effluent spray field. Best (2020) recommends establishing a special treatment zone around the spray area and restricting harvesting operations. During the PHI, it was noted that the silviculture break between transition and group selection harvesting was observed flagged approximately 30 to 50-feet downslope of the STZ. Concern was raised, that a harvesting or the placement of a group opening just downslope of the spray field may result in adverse impacts to slope stability. Extending the no harvest STZ downslope to the silviculture break will minimize the potential for adverse impacts to slope stability by retaining the existing canopy and root function.

Map Point D (Best, G16): The plan-attached geologic report (Best, 2020) describes an approximately 20-foot wide cut bank failure (labeled G16 by Best) along an existing seasonal road proposed for reuse. The road crosses approximately 50 to 70-percent slopes approximately 100 to 150-feet upslope of the head of a mapped Class III tributary to Mays Canyon, a Class I watercourse. Consistent with recommendations by Best (2020), the road was reopened by grading through the deposited material and feathering out the material to either side. During the PHI, unconsolidated earth

materials containing ground cracks was observed sidecast onto the steep slopes. Concern was raised that the unconsolidated material would mobilize during heavy rains and deliver to the Class III watercourse downslope. It was discussed that removing the sidecast material would minimize the potential for adverse impacts to slope stability and sediment delivery.

Map Point 1 (Best, G18): The intersection of an existing seasonal road and a Sonoma County maintained permanent road (Neeley Road) crosses a mapped Class II watercourse along the northwestern THP boundary via an approximately 100-foot long existing culvert. The culvert inlet is located below the upstream edge of the existing seasonal road within the northern THP boundary. According to discussions within the RPF and review of the plan-attached geologic report (Best, 2020), the culvert at the inlet is 24-inches in diameter. This was difficult to confirm, as the culvert was observed to be buried during the PHI. An approximately 6 to 8-foot deep basin was observed at the inlet, which likely allows low flows to pool and seep through to the buried inlet. The outlet of the culvert is located below the downstream edge of Neeley Road approximately 40 to 50-feet upstream of the confluence with the Russian River, a Class I watercourse. The outlet was observed rusted through and shotgunned approximately 4 to 5-feet above the outer road fill prism. An approximately 2-foot wide and deep gully was observed in the outer road fill prism below the outlet. Rock was observed in the gully below the shotgunned outlet that appeared to be minimizing erosion. During the PHI, the culvert at the outlet was observed to be approximately 12-inches in diameter, suggesting that the crossing consists of two culvert segments that are not the same diameter. The watercourse was dry during the PHI, but the observed condition of the culvert and an approximately 2-foot wide and long gully observed in the outer road fill prism below the outlet suggests that water likely pipes through the road fill.

Based on flow calculations included in the plan-attached geologic report (Best, 2020), the 24-inch diameter culvert at the inlet is significantly undersized to accommodate the 100-year flood flow and debris. An approximately 1 to 2-foot wide and deep rill observed along the seasonal road above the inlet suggests that the plugged culvert regularly overtops. The rill extends approximately 40-feet downslope to Neeley Road. An approximately 1-foot wide and deep gully in the outer Neeley Road fill prism across from the rill appears to indicate that the runoff is directed across the road running surface. Accumulated eroded material and rocky bed load observed along both sides of the Neeley Road running surface, suggests that material is deposited on the Neeley Road running surface, likely necessitating cleanup by Sonoma County road crews.

Special Treatment Zone G3: The plan-attached geologic report (Best, 2020) maps an approximately 1.5-acre historically-active deep-seated translational landslide within the northern THP boundary. The unstable feature appears to toe into the Russian River and is characterized by 8 to 15-foot high near vertical scarps above a benched failure slope that supports mostly straight-standing and few leaning or pistol-butted second growth conifers. Neeley Road, which is a public access road for the Vacation Beach and Edendale residential communities, crosses the toe of the slide approximately 75 to 100-feet upslope of the Russian River. During the PHI, an existing residential structure was observed along Neeley Road downslope of the northern corner of the THP boundary. Based on mapping by Best (2020) and review of available lidar imagery (2014), it appears that the residential structure is located just above and outside of the northeastern lateral scarp of Slide G3. Best (2020) recommends establishing a special treatment zone (STZ) around Slide G3 from the THP boundary extending upslope of the mapped slide. The THP boundary was observed flagged approximately 75 to 100-feet upslope of Neeley Road. Harvesting within the STZ is to be limited to ground-based single-tree selection with a minimum retention of 100-square feet of total basal area and no group openings. During the PHI, the THP boundary was observed flagged across Slide G3 just downslope of the distinct 8 to 15-foot high head scarp of G3. It appeared that only a few conifers were observed marked for harvest downslope of the scarp. In an effort to

Map Point 3: Prior to second review, Section II of the THP shall be revised to describe that a minimum 24-inch diameter culvert will be installed at Map Point 3. The revised flow calculations shall be included in Section V of the THP.

Special Treatment Zone G10: Prior to second review, Section II of the THP shall be revised to describe that the special treatment zone (STZ) shall extend downslope to the flagged silviculture break. The extended STZ shall be identified on the THP maps.

Map Point D: Prior to second review, Section II of the THP shall be revised to describe that the perched and cracked fill will be pulled back and incorporated into the existing road running surface.

Map Point 1: The public safety concerns regarding failure of the crossing shall be described in Section II of the THP and in the plan attached geologic report (Best, 2020). A copy of this memo shall be cc'd to Sonoma County staff. Without additional mitigation it is unclear how the THP minimizes adverse impacts to slope stability and public safety. As discussed during the PHI, the RPF and landowner shall coordinate with Sonoma County to minimize the existing public safety hazard. If the County refuses or is unable to prioritize replacement of the crossing then it should be clearly understood that a potential for adverse impacts to Neely Road continues. Documentation of Sonoma County refusal shall be included in the THP with an acknowledgement by both Sonoma County and Redwood Empire Sawmills that the public safety hazard continues to exist. CGS assumes no liability in the event that Neely Road is impacted by upslope conditions in the future.

Special Treatment Zone G3: Prior to second review, the THP maps shall be revised to accurately show the revised northern THP boundary.
