Inspection Memorandum

Date: August 5, 2020

Subject: Preharvest Inspection (PHI) Report and Recommendations
1-20-00084 SON, "Silver Estates" PHI

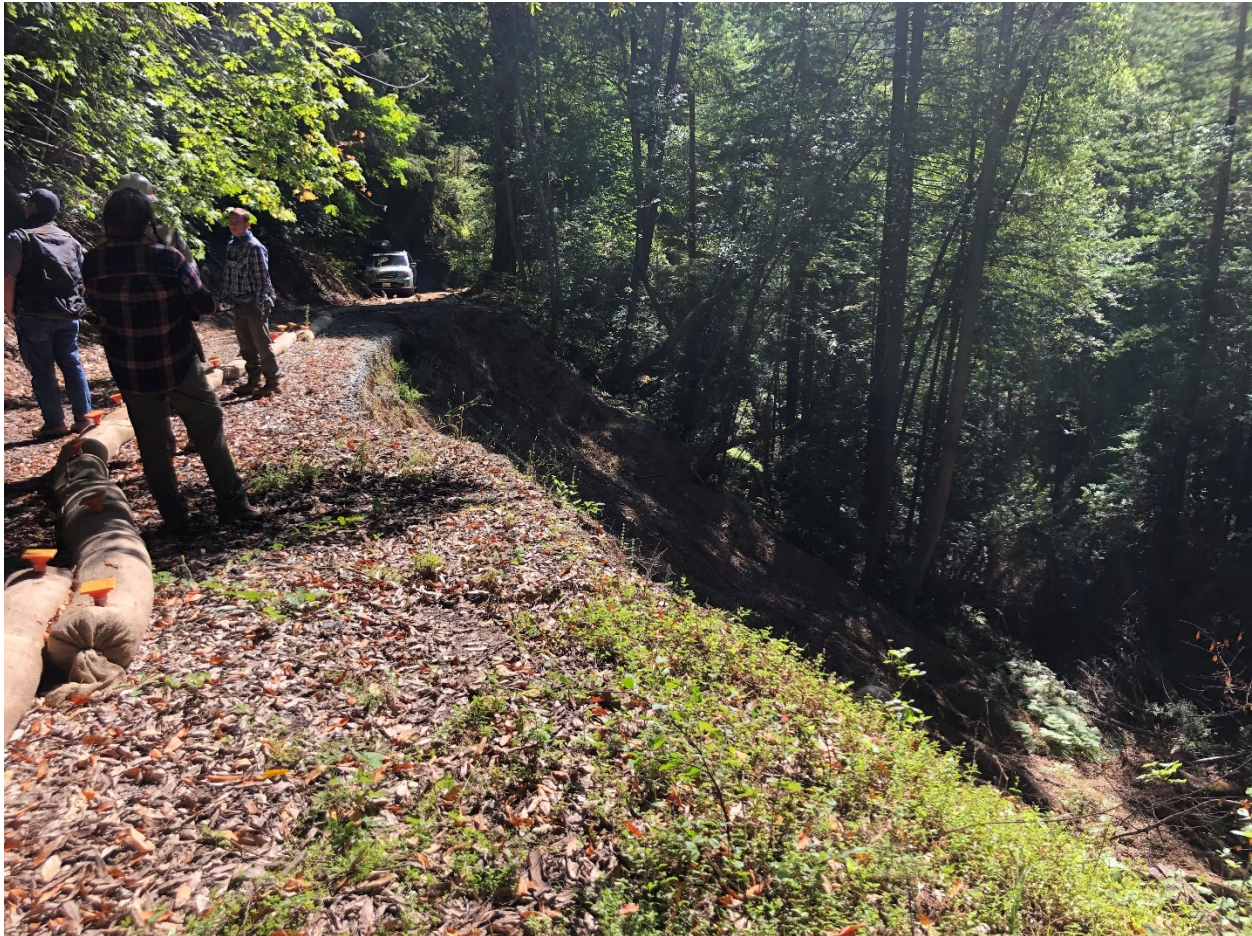
During the PHI, RWB staff observed a road fill failure and associated debris slide. The failure occurred on a permanent road constructed on an ~85% slope above a Class III watercourse, extending about seven feet into the old road prism and narrowing the road to less than seven feet in width. The failure is approximately 75 feet wide, 40 feet long and 4 to 8 feet deep (Fig 1.) Sediment and debris from the failure entered the Class III watercourse at the foot of the slope, but reportedly did not reach the Class I watercourse in Mays Canyon. Two options for remediation are presented in the THP. Generally, either option proposed – widening the road into the cut bank or rebuilding the fill with a retaining wall – should serve to protect water quality.

Figure 1. Looking northeast (downhill) and fill failure at Map Point E.

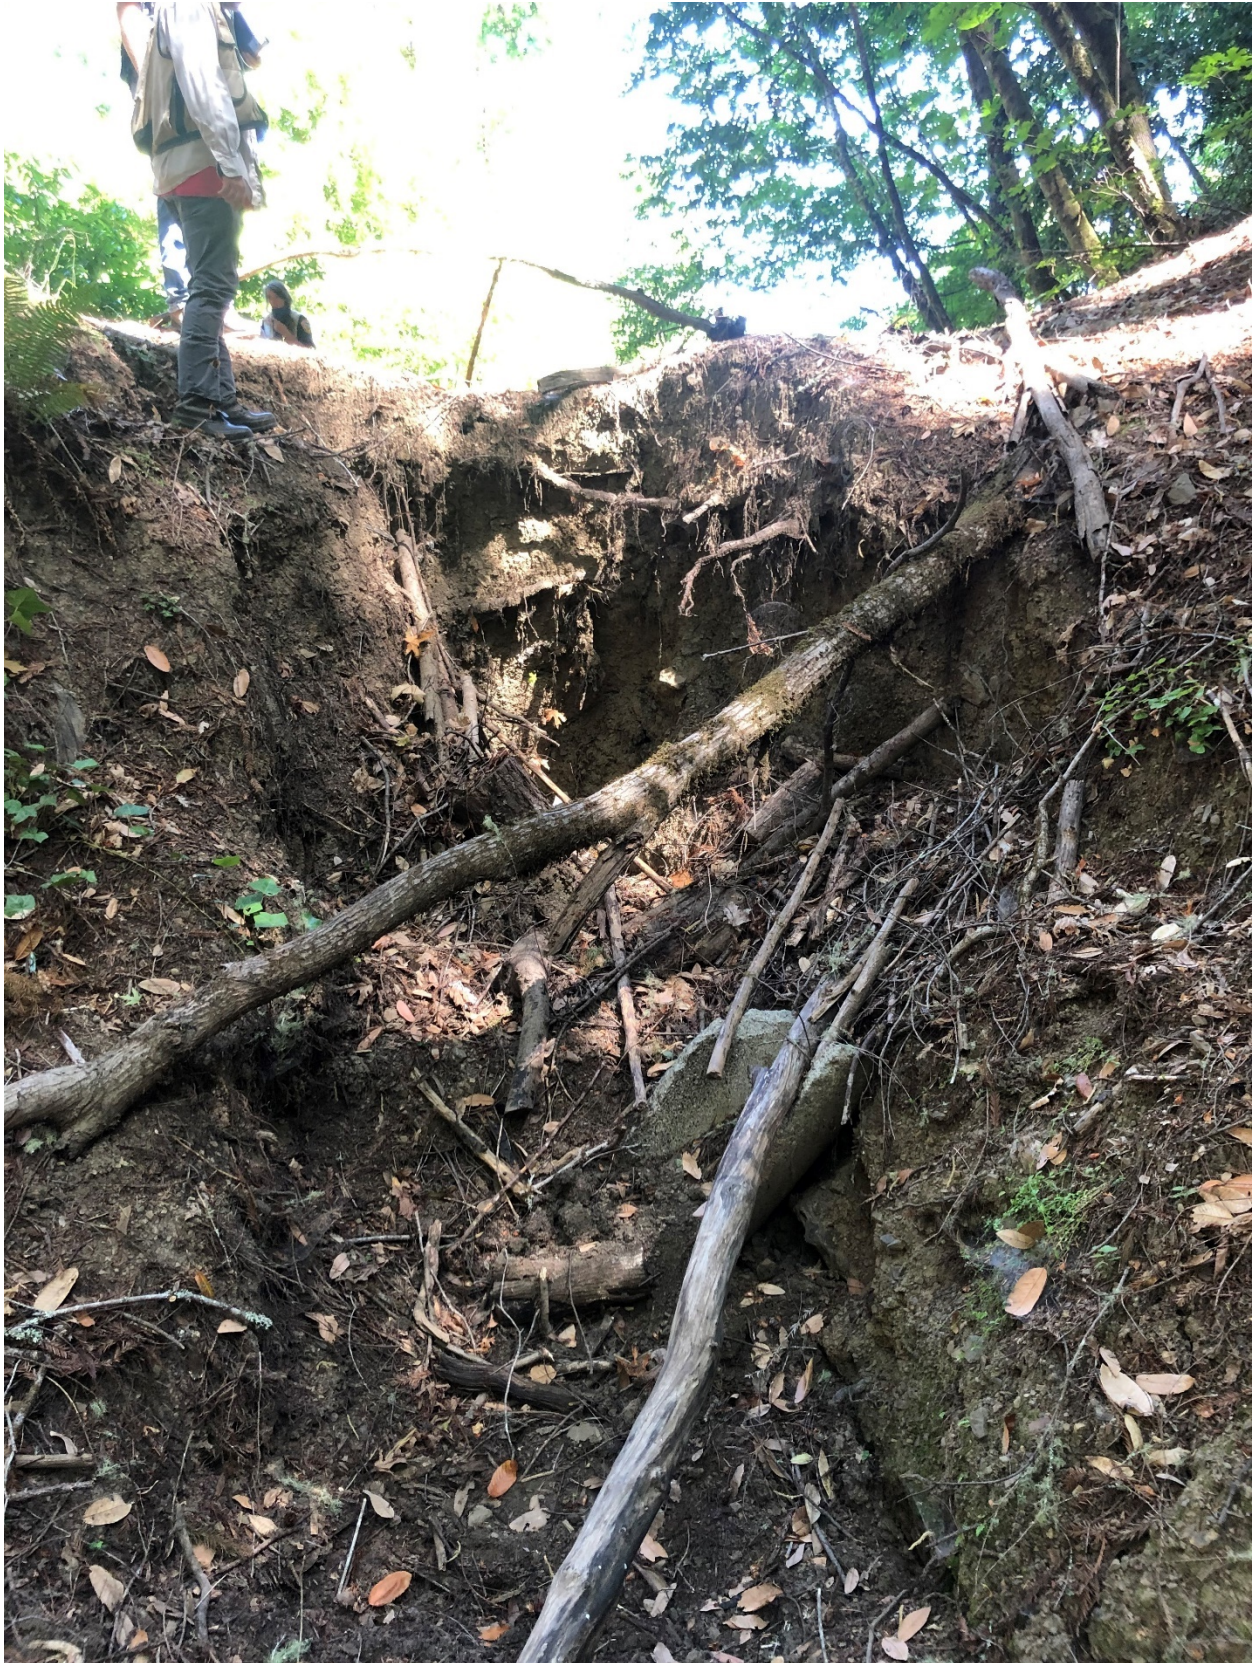
Map Point 1 is a 100' long, 24" diameter culvert where a Class II stream crosses the main haul road and Neely Road before entering the Russian River. The culvert inlet appeared to be fully buried and was not visible during the inspections. A ~8' deep pool with over-steepened banks had formed at the inlet (Fig 2.) The stream had overtopped the pool at some point in the past and diverted down the main access road and eroded a 6" to 12" deep gully (Fig 3) down the road before crossing Neeley Road and entering the Russian River. There are signs of erosion on the outboard edge of Neeley Road where the outflow exits the road (Fig 4.) The outlet of the culvert is shotgunned (Fig 5) and rusted through (Fig 6.) In addition to the issues above the culvert is undersized and in need of replacement. The consensus of the review team was that all reviewing agencies should work with the Sonoma County Department of Transportation and Public Works to prioritize replacement of this culvert.

Figure 2. Inlet and over-steepened banks at inlet of culvert at Map Point 1.

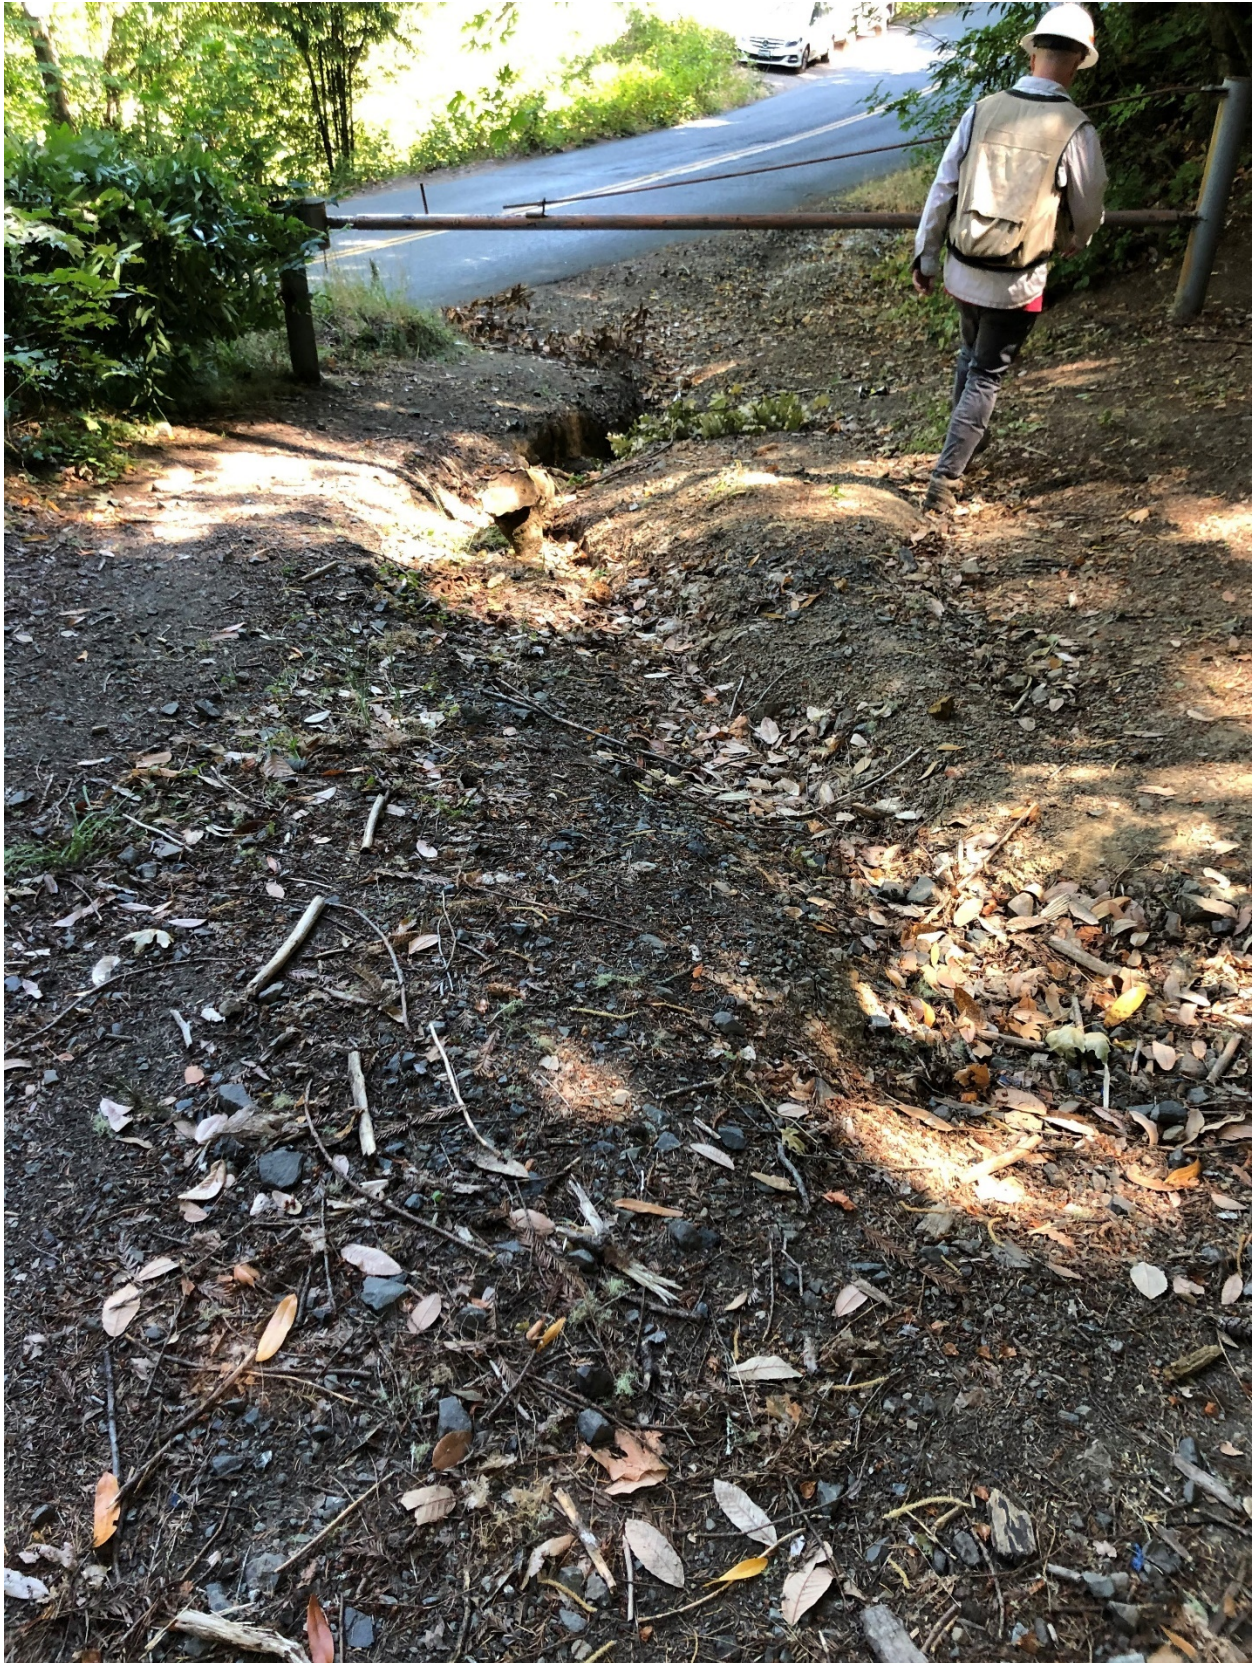
Figure 3. Gully erosion caused by overtopping of inlet pool at Map Point 1.

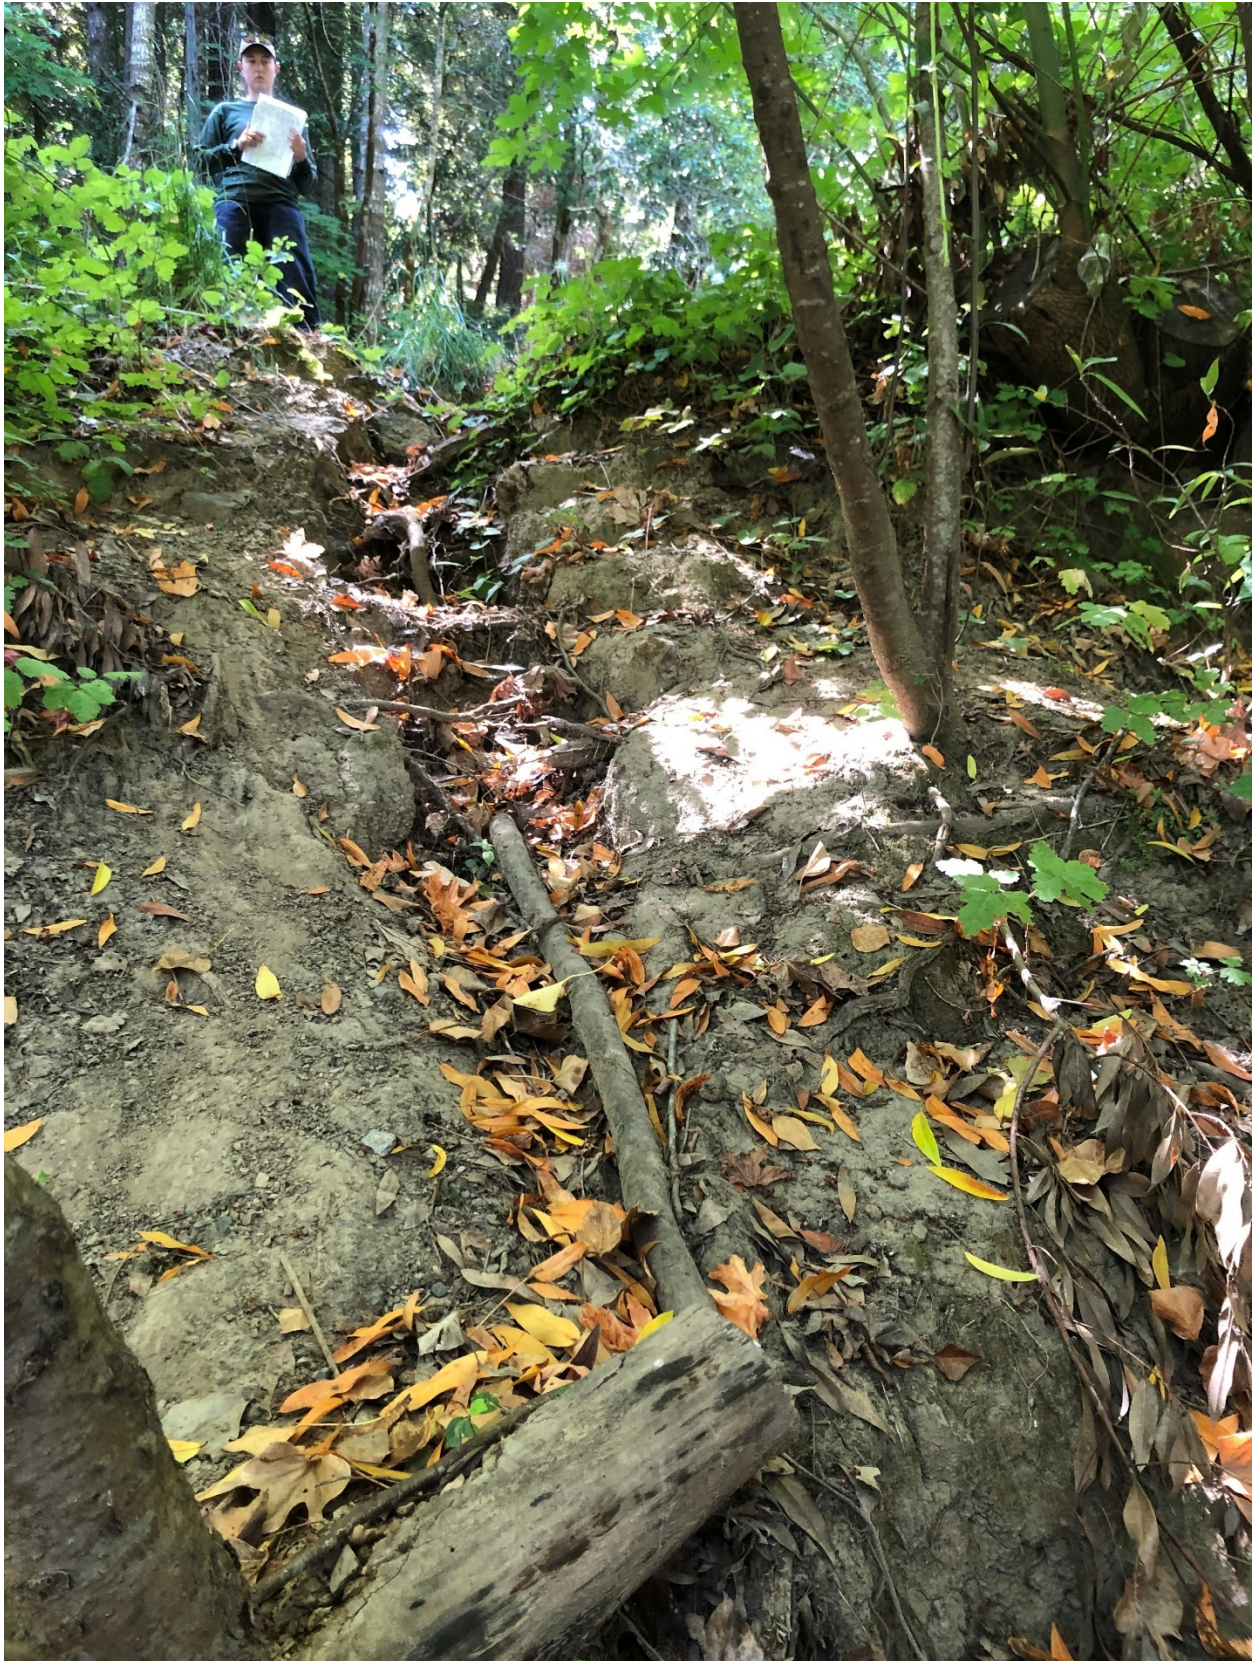
Figure 4. Erosion on outboard edge of Neeley Road at Map Point 1.

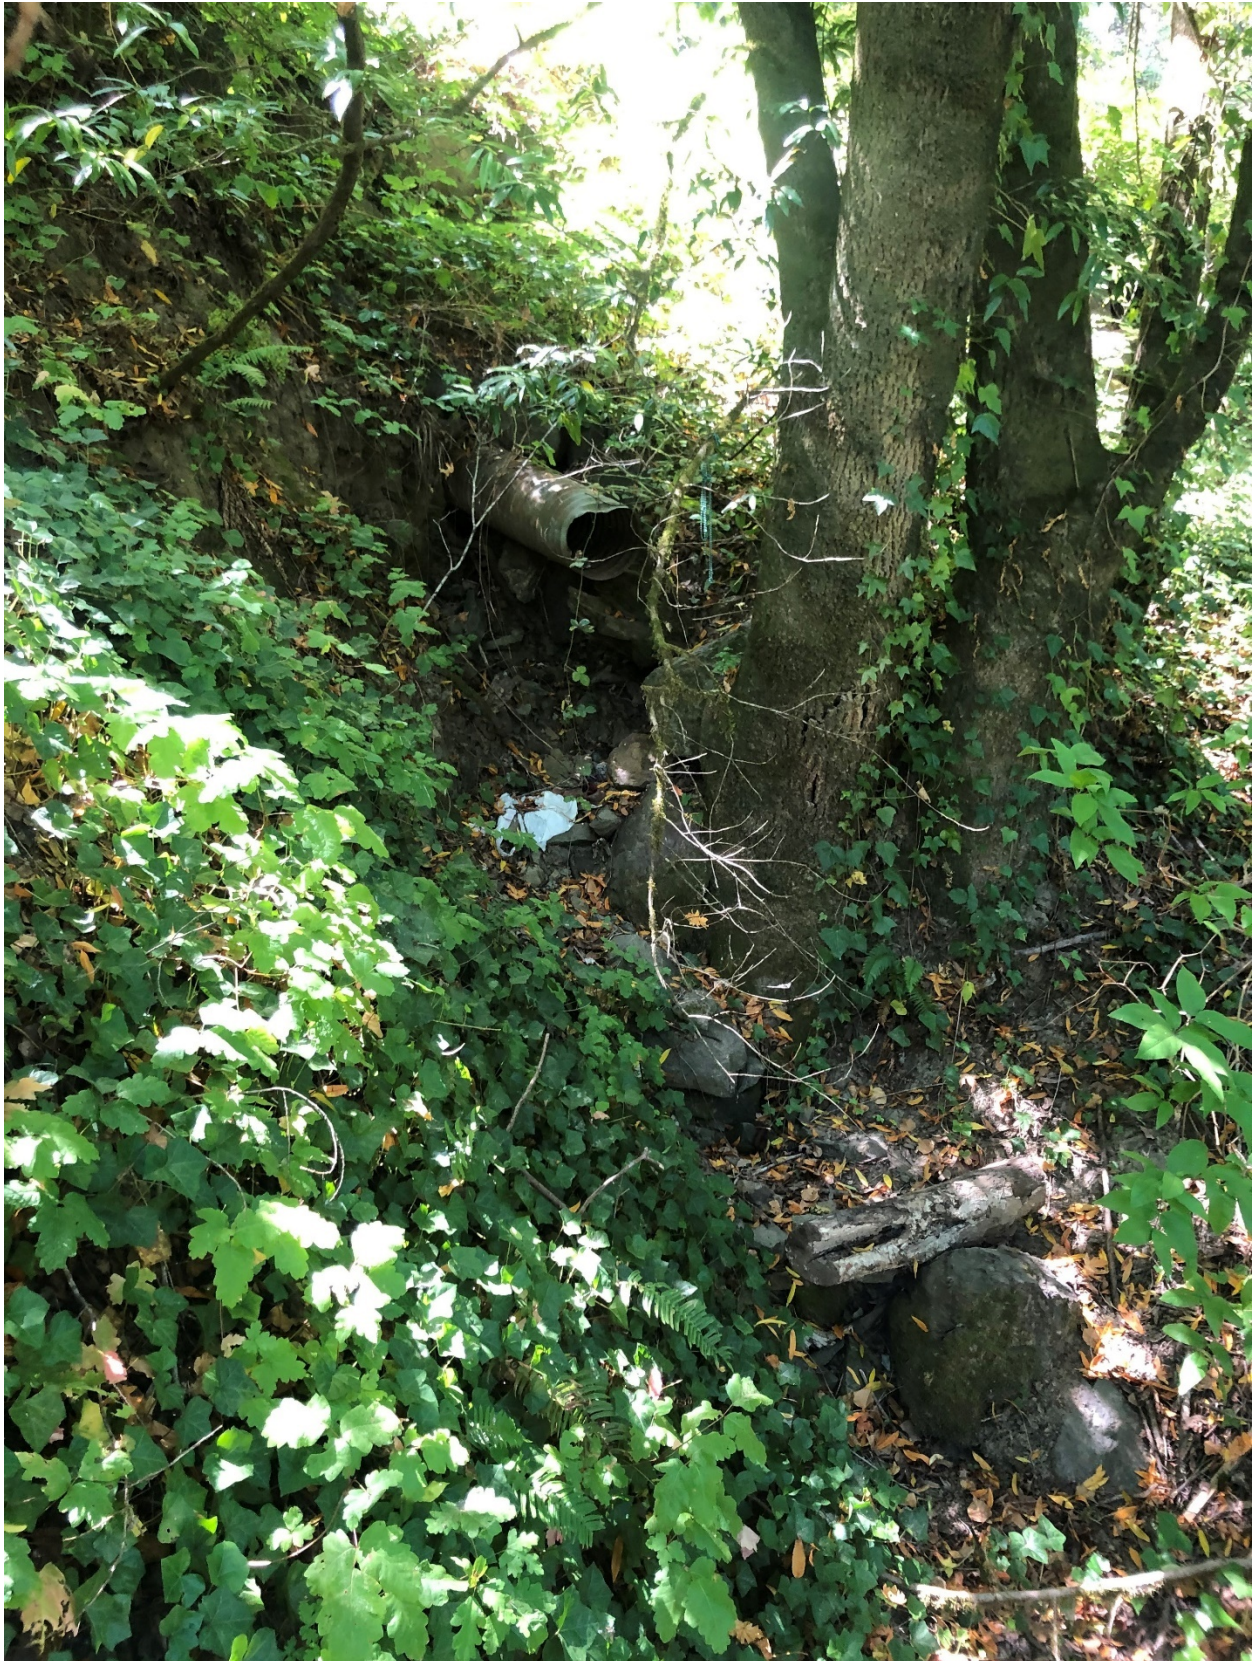
Figure 5. Shotgunned culvert outlet on Neeley Road at Map Point 1.

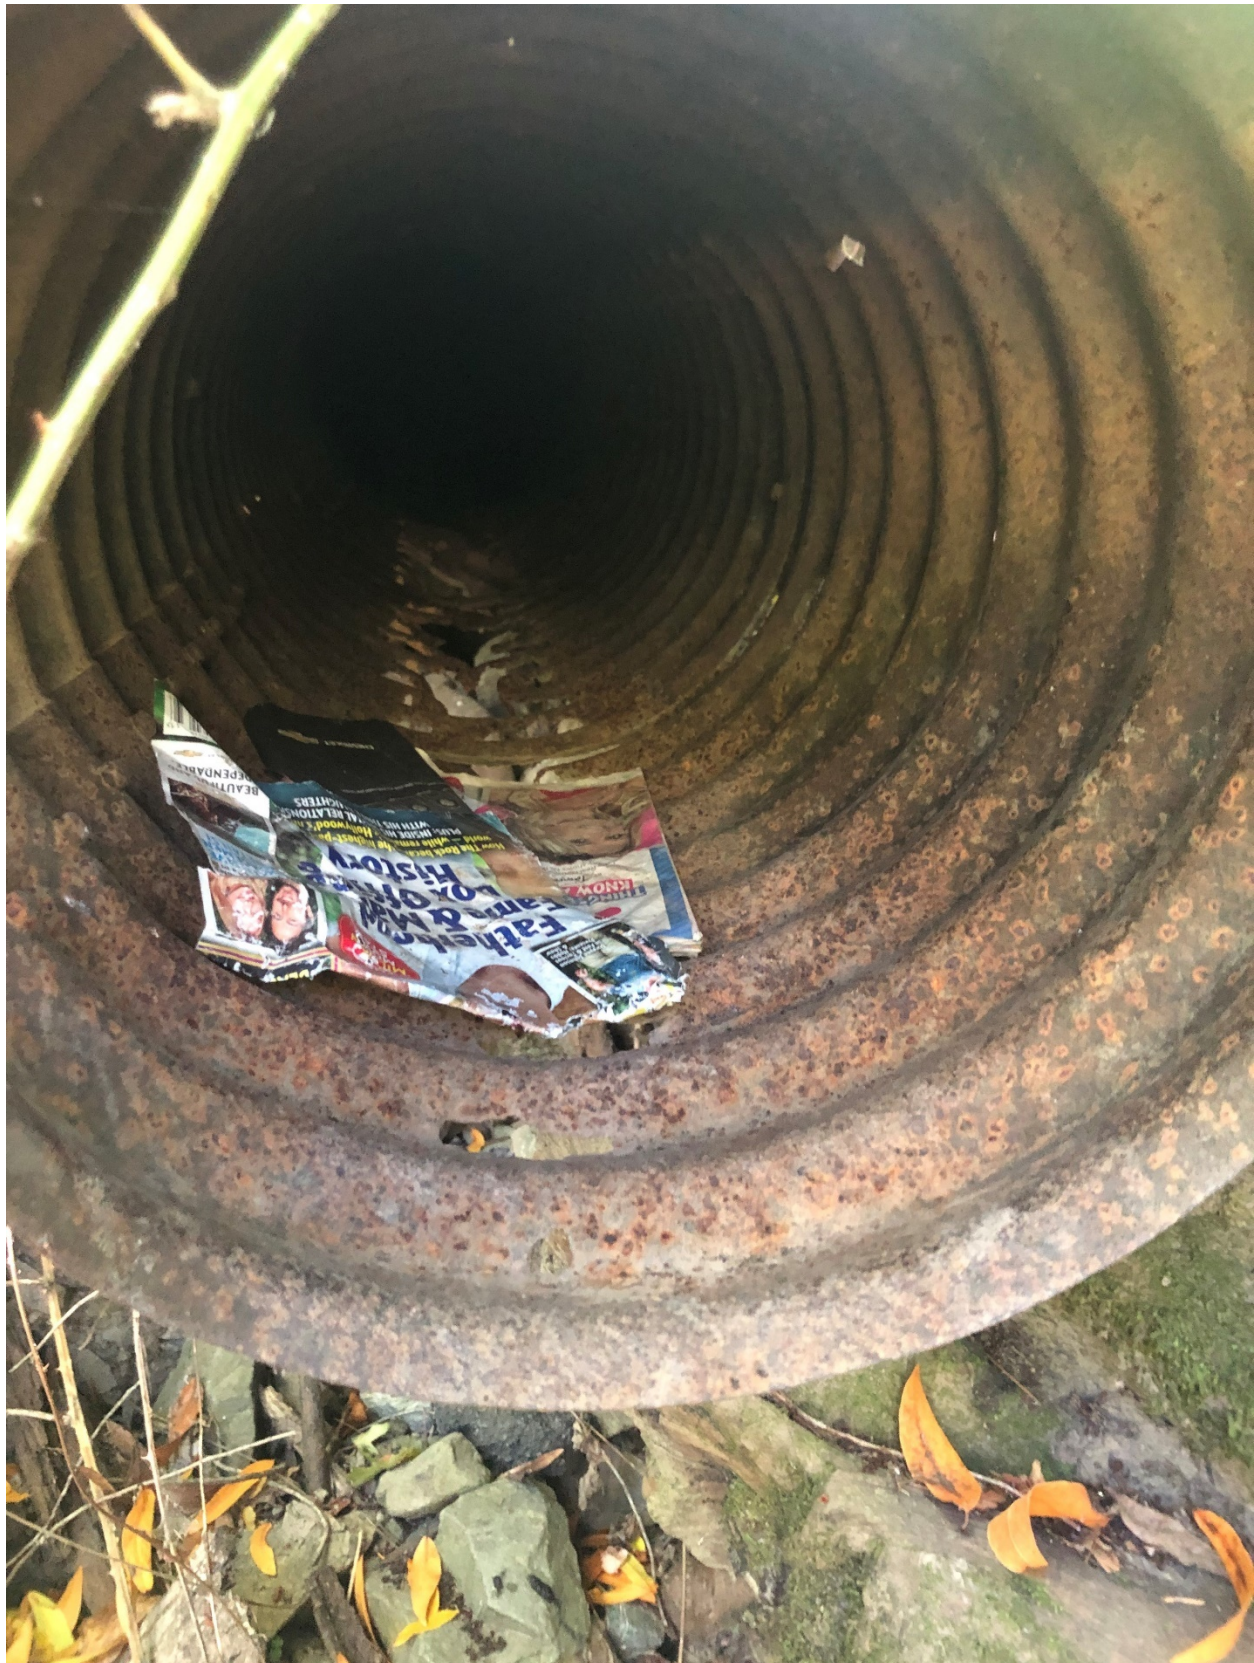
Figure 6. Culvert outlet rusted through at Map Point 1.
